Journal of Technology Research (JTR)
Volume 1, Issue 1, (2023), pp 102-113, ISSN 3005-639X

Inspection the Fuel Spray Pattern of The Injector Nozzle in Turboprop Engine by Using Fuel Testing Device

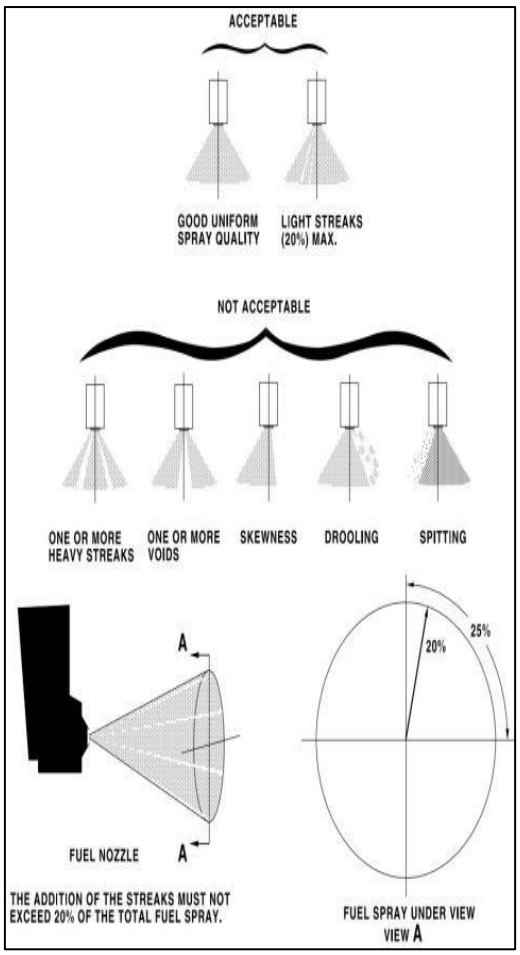
Fig. 6. Acceptable and unacceptable conditions of fuel spray pattern [9].

1. "Spitting": is a condition which exists when large drops of anatomized fuel occur intermittently and usually on outside of spray cone.

The reason: Caused by carbon deposit at nozzle face.

2. "Drooling": is a condition which occurs when large drops of anatomized fuel form on nozzle face.

The reason: Caused by carbon deposit at nozzle orifice or by partial obstruction of fuel nozzle distributor.

The reason: Caused by obstruction on internal fuel passage.

4. "Skewness": describes a spray condition that is not centered.

The reason: Caused by damage to nozzle orifice.

The repairing: Brush nozzle during flow test.

The repairing: Brush nozzle surface during flow test and ultrasonically clean. [9]

The repairing: Clean by ultrasonic device. [9]

The repairing: Not repairable at field level. [9]

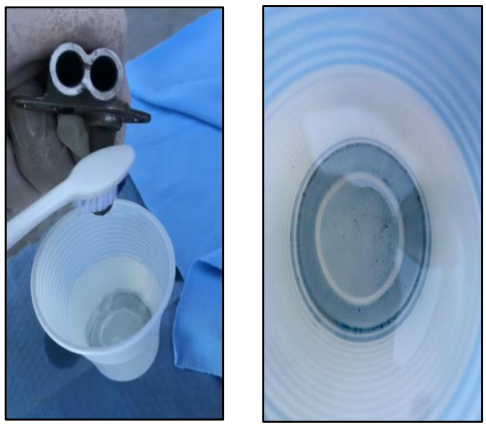
Fig. 9: During cleaning procedure.

During the cleaning process, it was observed that carbon particles fell into the cleaning fluid, as in Figure 9. The fuel injector head and fuel injector cover must also be cleaned well and the thickness of the injector cover must be checked so that the thickness of the cover is not less than 0.040 inches. [9]

Due to expose the injector cover to combustion heat inside the combustion chamber and particles of carbon which resulting from combustion cause corrosion of the tip of the injector cap, this is why the thickness of the injector cap must be periodically checked. If it is less than the required thickness, it must be replaced.

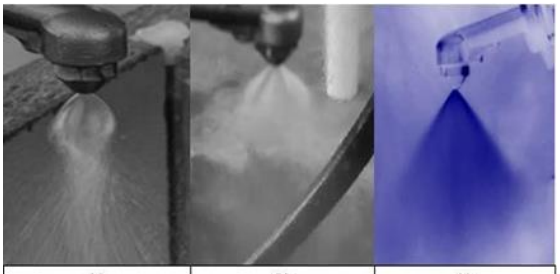
Fig. 13. Obtaining result of spray pattern in case 01 of at different conditions so that Fig (a) At low pressure1.2 bar (20 psi), (b) At medium pressure 2 bar (30 psi), and (c) At high pressure 4.1bar (60 psi)

Figure 13, illustrated the shape of spray pattern in case 01 at different conditions, based on the spray shape obtained at all pressures in the test, the fuel injector is good and does not need re-cleaning or other maintenance. Comparing the shape of results with an acceptable spray pattern in figure 6 was conforming. So, it is ready to installed in the aircraft engine, based on maintenance instruction.

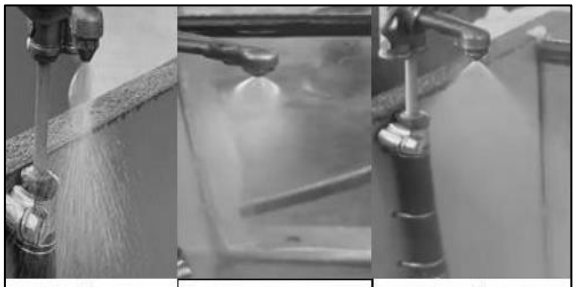
Fig. 14. Obtaining result of spray pattern in case 02 at different conditions so that Fig(a) At low pressure 1.2 bar (20 psi), (b)At medium pressure 2 bar (30 psi), and (c)At high pressure 4.1 bar (60 psi)

Figure 14, illustrated the shape of spray pattern in case 02 at different conditions. This test was also carried out by taking a random sample from the engine and it was manually cleaned and tested and the following results are obtained from the spray patterns. Based on these results,

it is a good fuel injector and can be installed in the aircraft.

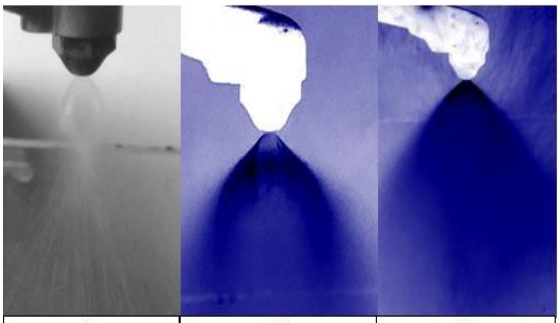
Fig. 15. Obtaining result of spray pattern in case 03 at different conditions so that Fig(a) At low pressure 1.2bar (20 psi), (b)At medium pressure 2 bar (30 psi), and (c)At high pressure 4.1bar (60 psi)

Figure 15, illustrated the shape of spray pattern in case 03 at different conditions. The third case was taken after three months from case 01 and 02, Found the results that the spray pattern of the injector is good and acceptable, and there is a little bit space in spray in case 03 at medium pressure but it is generally acceptable, while the results at figure 15 (c) and (a) are acceptable and confirmed with acceptable spray pattern in figure 6.

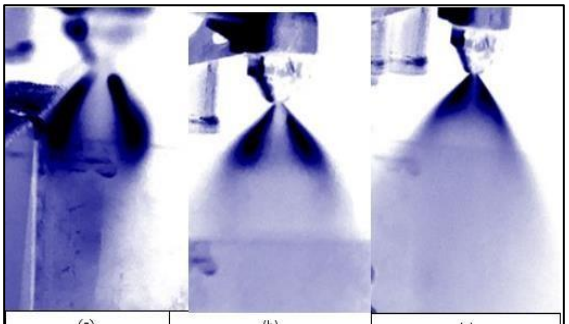
Fig. 16. Obtaining result of spray pattern in case 04 at different conditions so that Fig(a) At low pressure1.2 bar (20 psi), (b)At medium pressure 2 bar (30 psi), and (c)At high pressure 4.1bar (60 psi)

Figure 16, illustrated the shape of spray pattern in case 04 at different conditions. As seen in the results of spray pattern at all conditions are not acceptable comparing with an acceptable case in figure 6. the shape of spray appears a void in the middle and this is not allowed and the causing is obstruction on internal fuel passage and to repair this problem need to clean by ultrasonic device.

From obtained results, most of the cases were acceptable and does not need to re-cleaning after testing, except case 04 was not acceptable and need to clean by ultrasonic device. The reason that made the case 04 not acceptable was the formation of carbon disposed on the nozzle tip, it was more than the other nozzles tips. The fourth case can become acceptable if it is cleaned well and tested several times or cleaned with an ultrasonic device because it is effective in cleaning the injectors.
